MARINE INVESTIGATION REPORT
M00C0069

STRIKING

BULK SELF-UNLOADER "ATLANTIC HURON"
AND
CANADIAN COAST GUARD SHIP "GRIFFON"

PELEE PASSAGE, LAKE ERIE
25 SEPTEMBER 2000

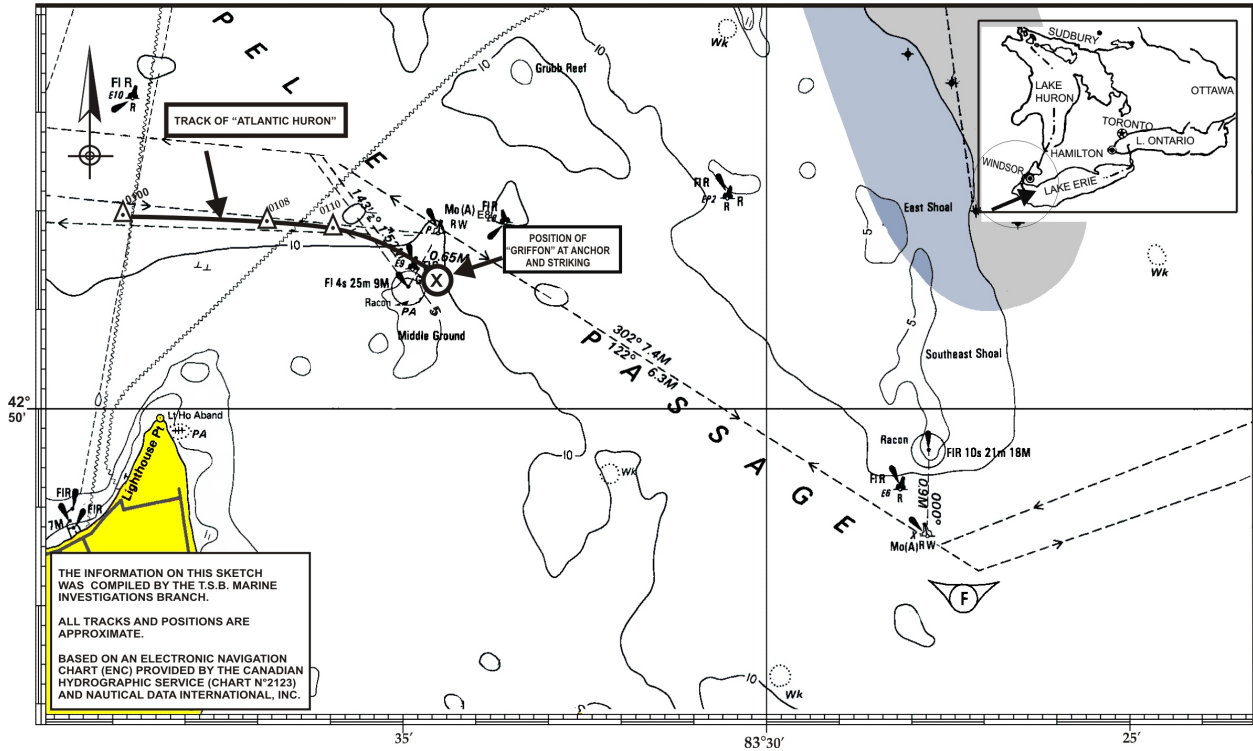
Figure 1. Sketch of occurrence area.

Pelee Passage is the main shipping channel for commercial vessels crossing western Lake Erie (see Figure 1). The fixed light is situated on a pier south of the light buoys at the north end of Middle Ground Shoal and is shown from a circular tower which extends up from a 14-m square helipad. A radar beacon (RACON) is fitted above the light.
